DAVID TURNER ARCHITECT, P.C.

I N S P E C T I O N R E P O R T

LOCATION: 39 Clarkson Street

39 Clarkson St. renovation, change of contractor.

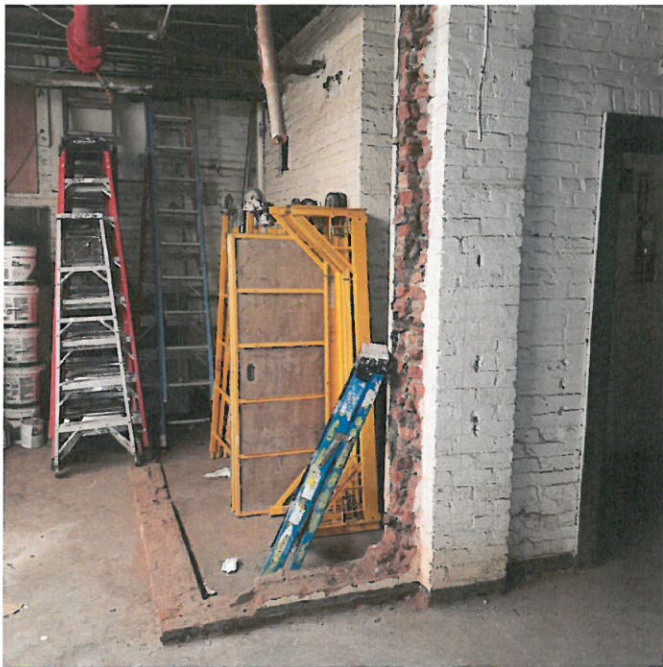
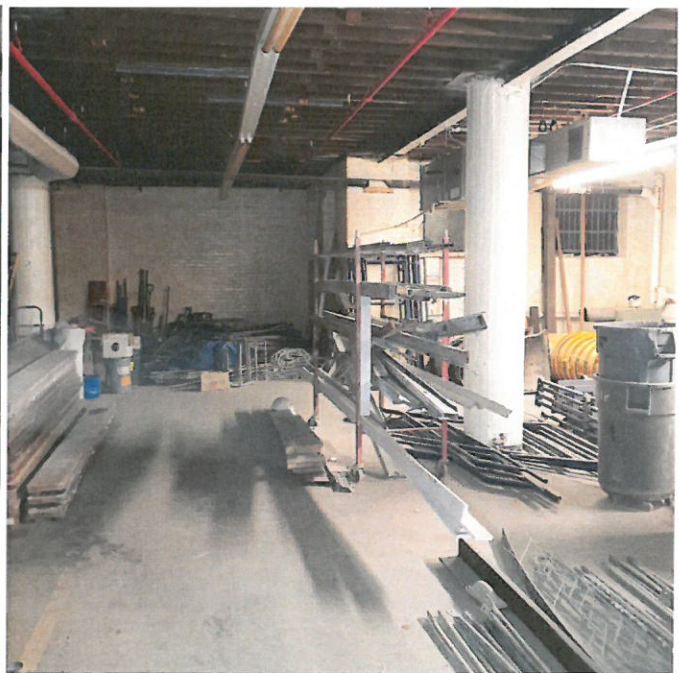
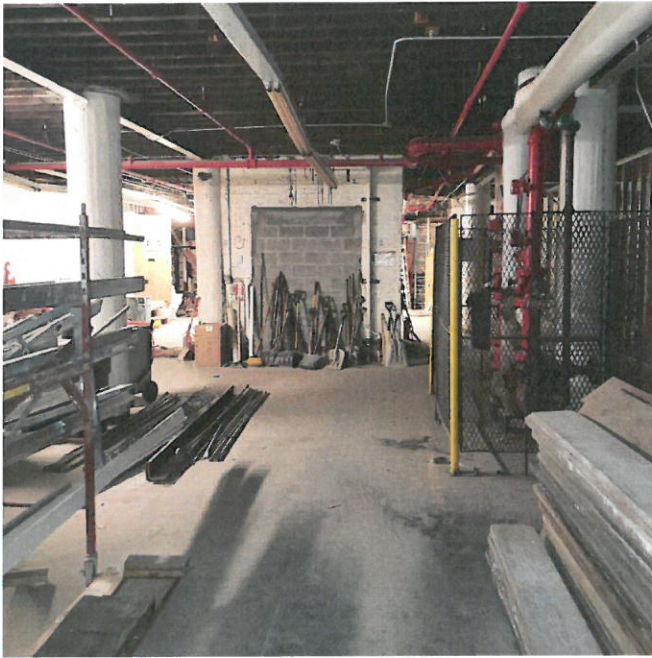
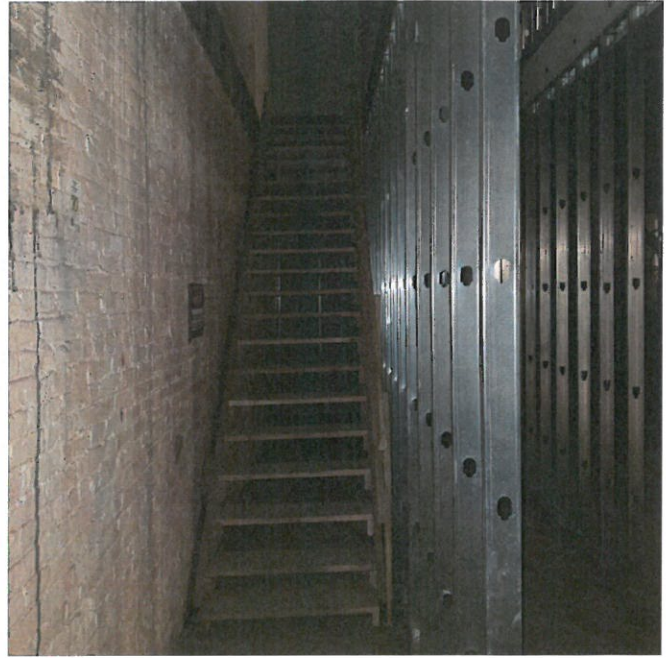
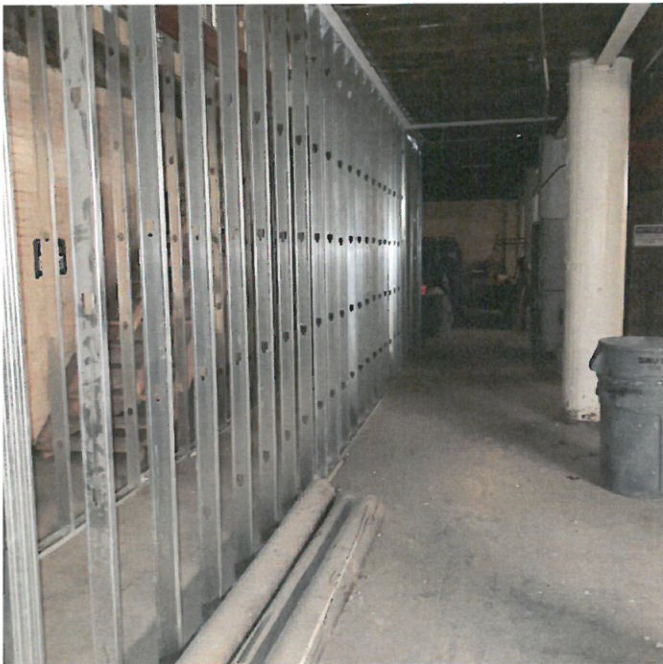
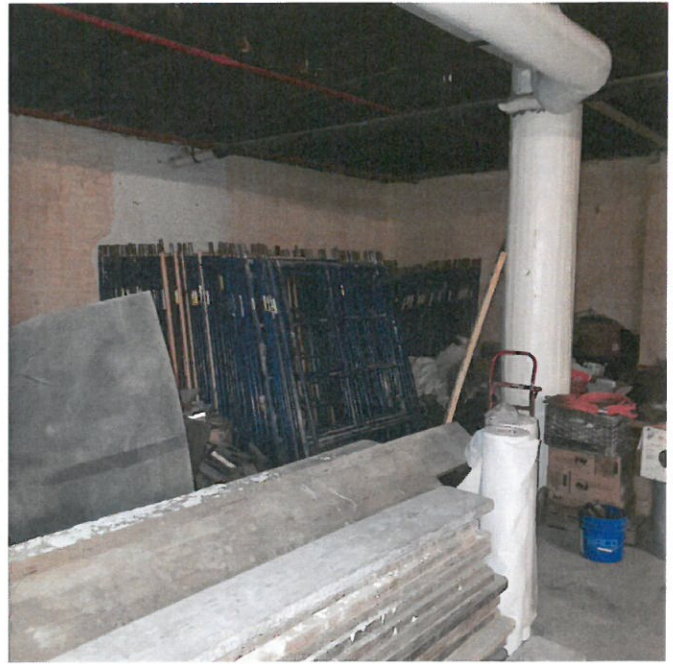
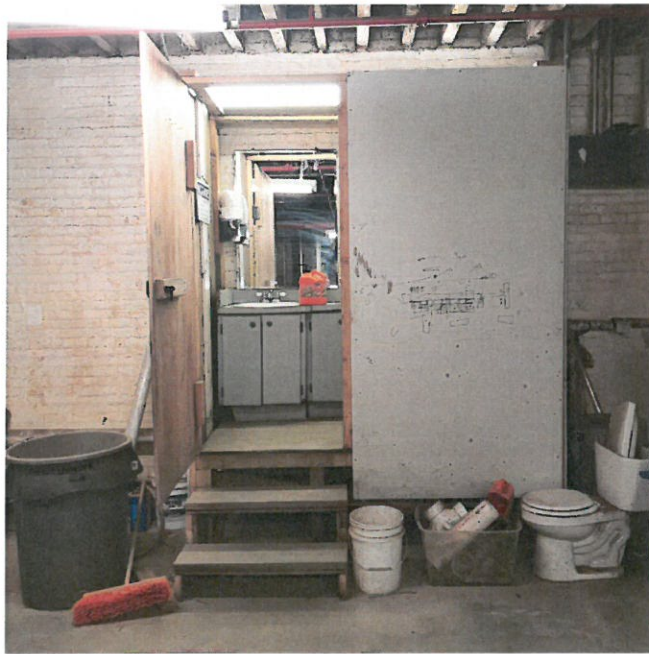
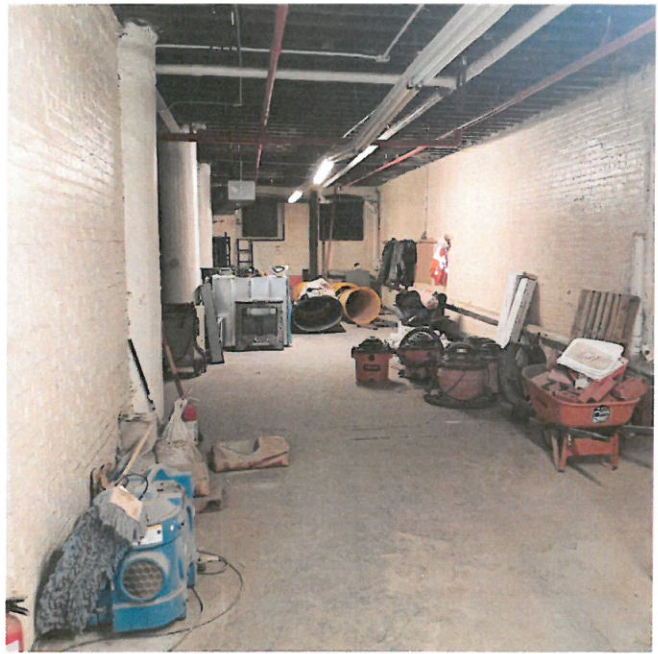
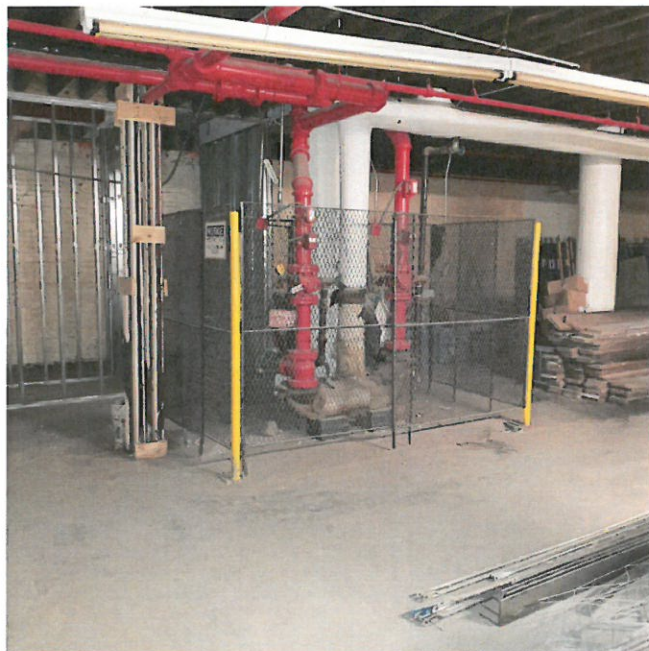
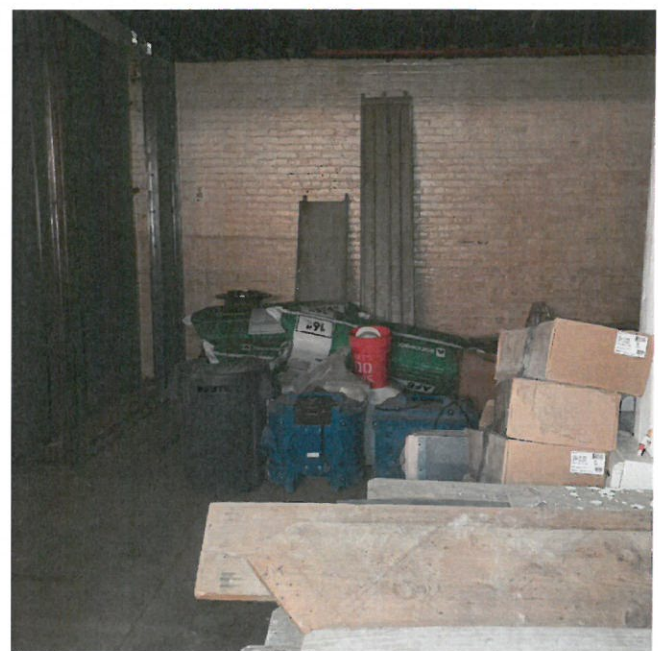
Basement Level

Tools are left on the site, scaffold and chutes and miscellaneous hand tools remain.

The stair and retail ground floor lowered lobby steel framing and deck are complete.

No concrete work is done throughout.

No MEP work is done in basement.

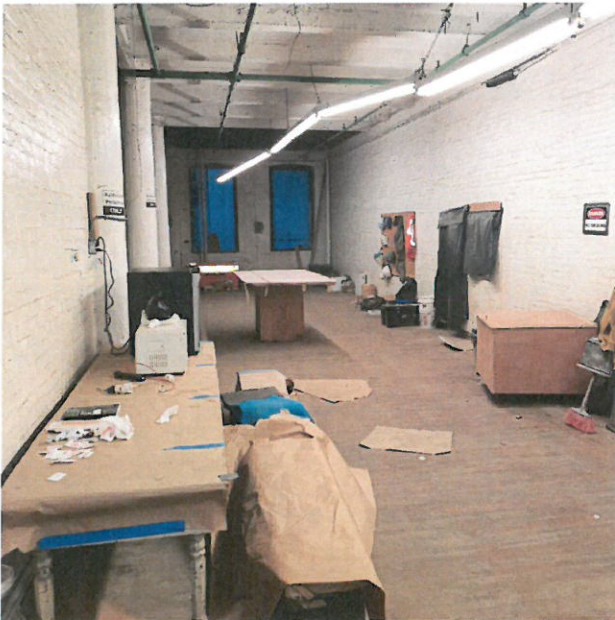
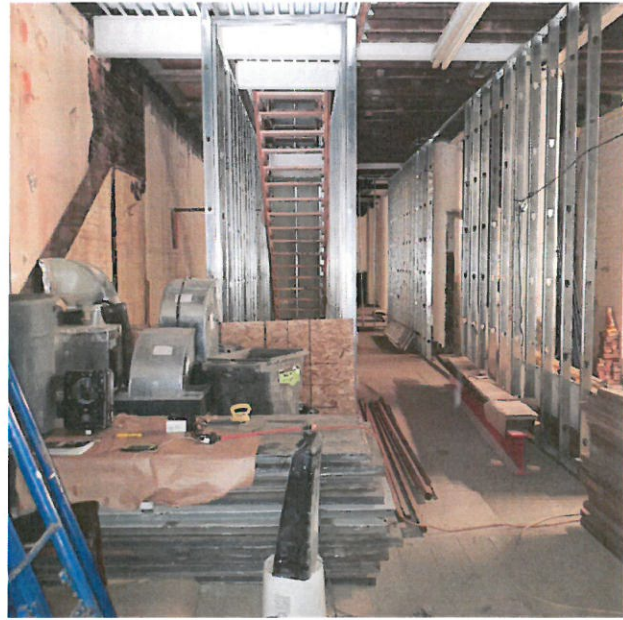
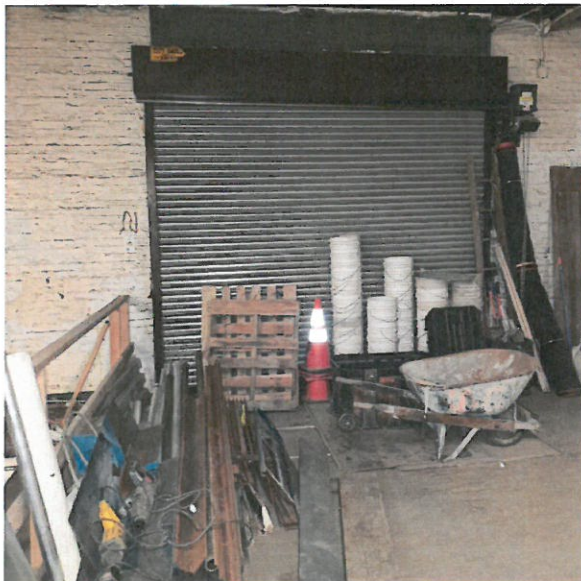
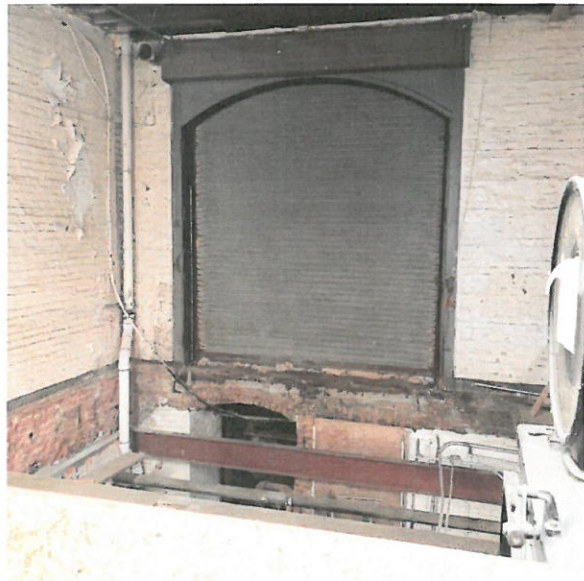
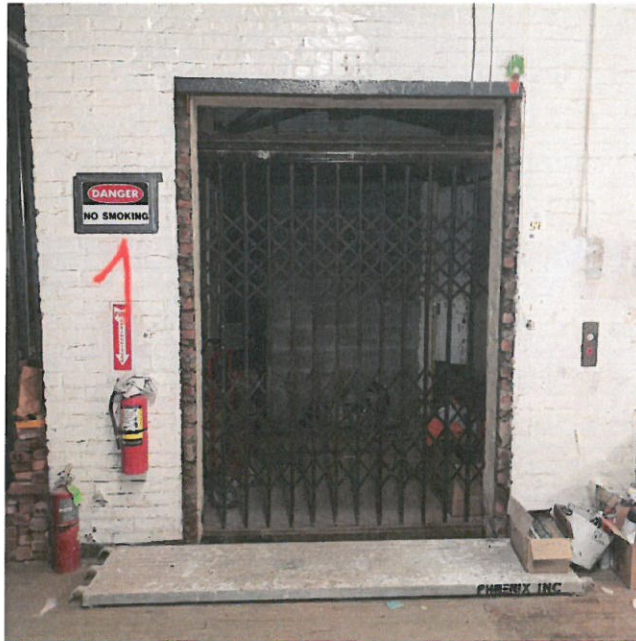
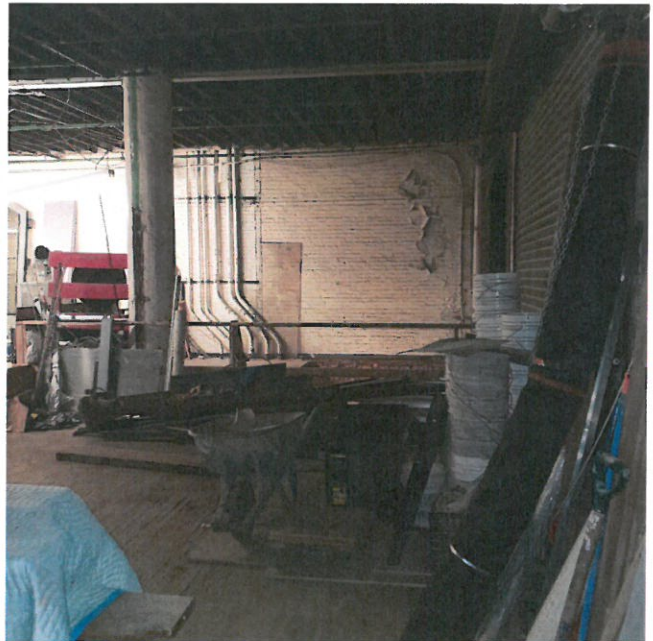
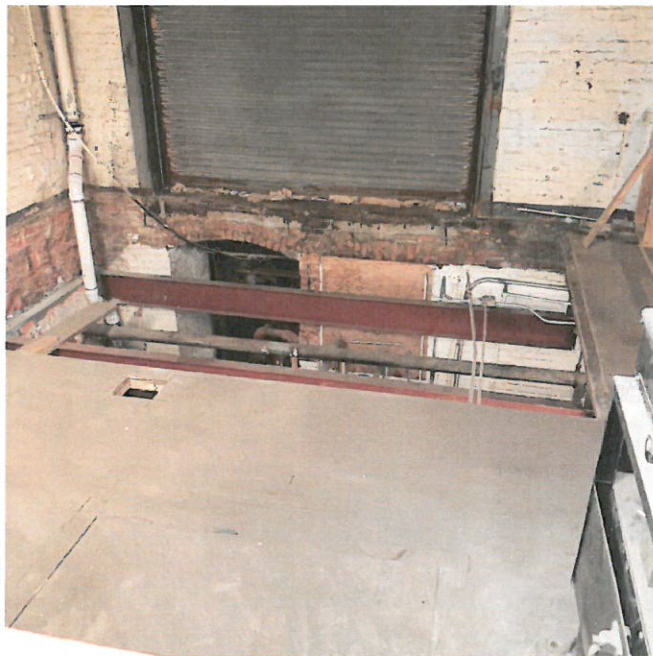
Ground Floor

Some boxes of tile for fifth floor are still on the floor.

Some Minor Equipment and tools are left.

Plumbing risers are se, but not connected.

Steel framing and deck for stairs are in.

Stair partitions and duct shaft are framed.

Temp stairs installed.

No MEP other than water and waste risers.

Water and waste risers end at first floor per photo below and are not connected to water supply or sanitary line.

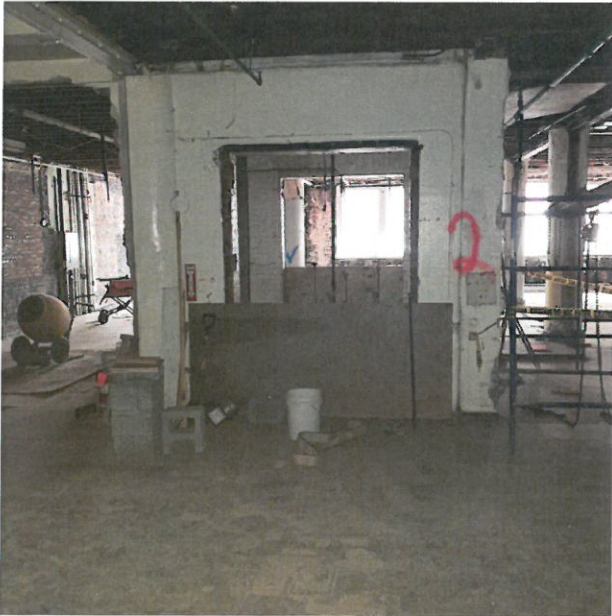
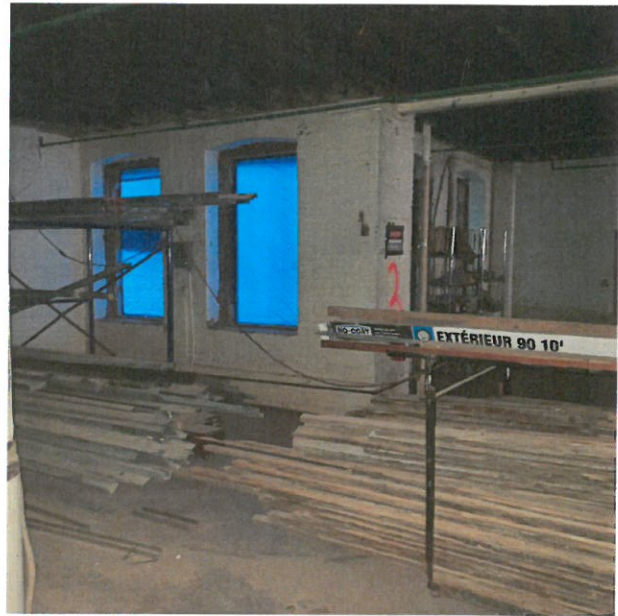
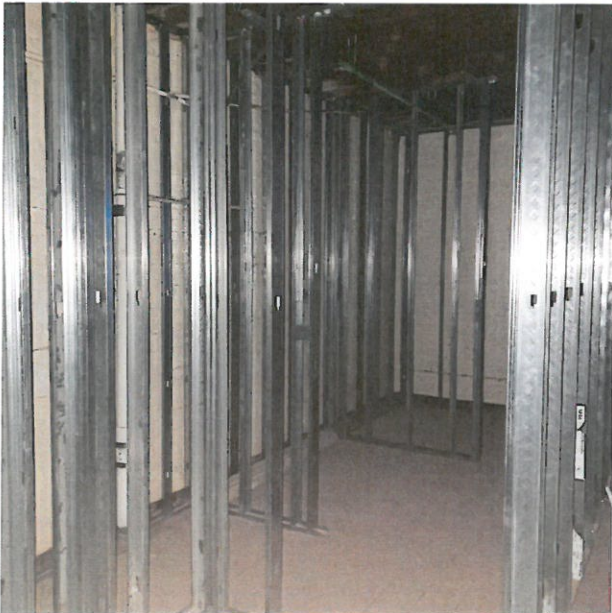
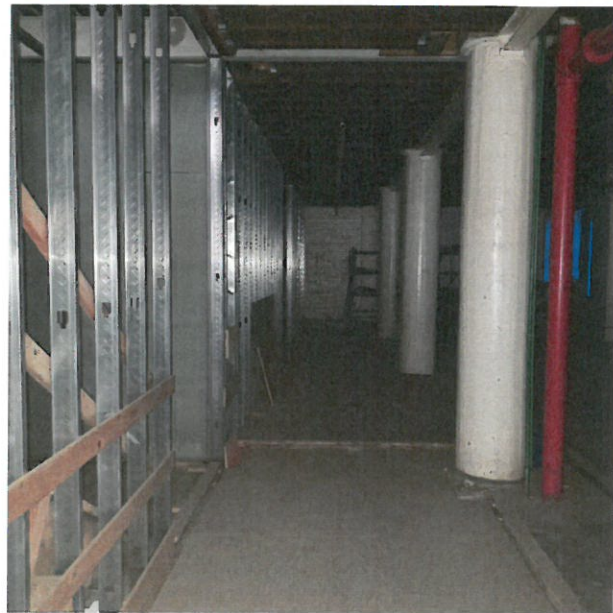
2nd Floor

Miscellaneous material & Equipment are left on the floor.

Plumbing risers are set.

Steel framing and deck for stairs are in.

Stair partitions and duct shaft are framed.

Temp stairs installed.

No MEP other than water and waste risers.

Boxes of tile are on the floor, intended for the fifth floor.

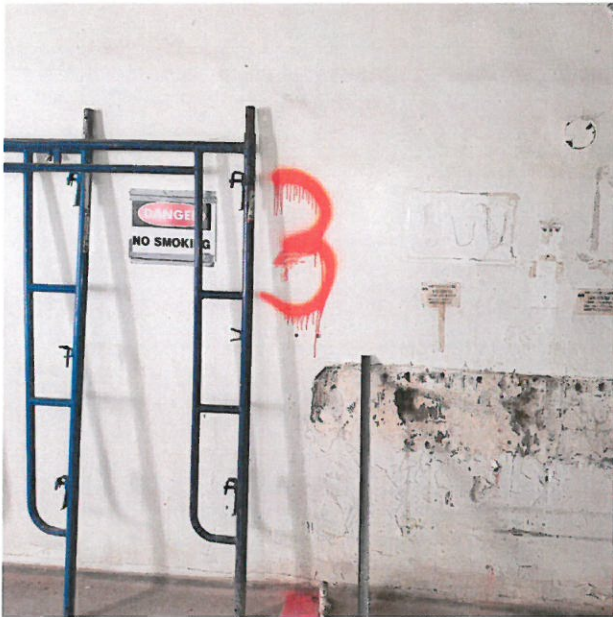
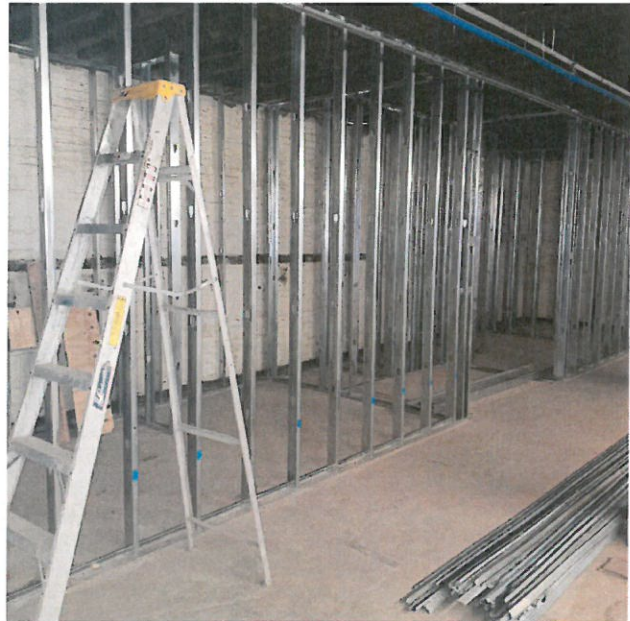
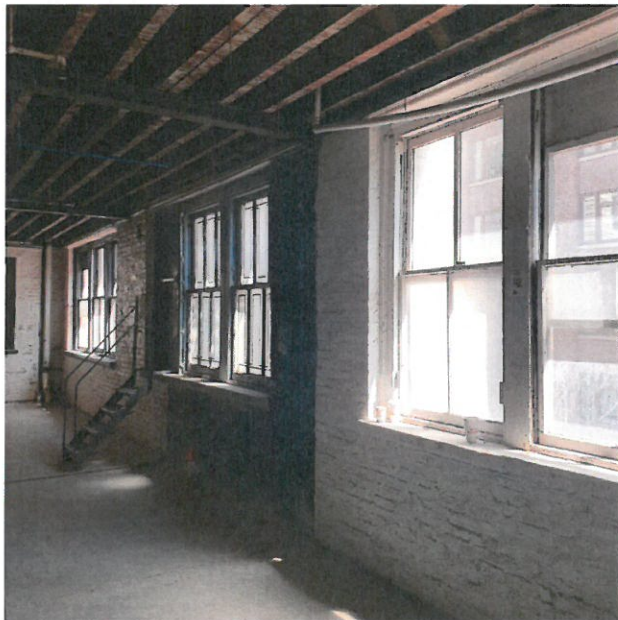
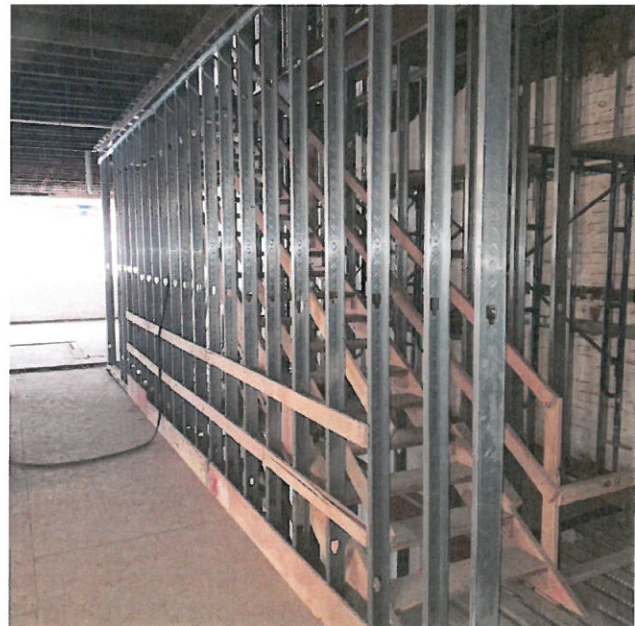
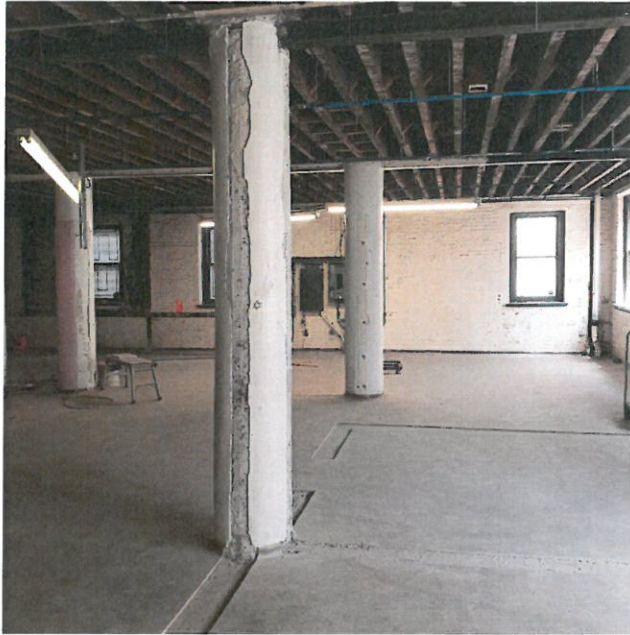
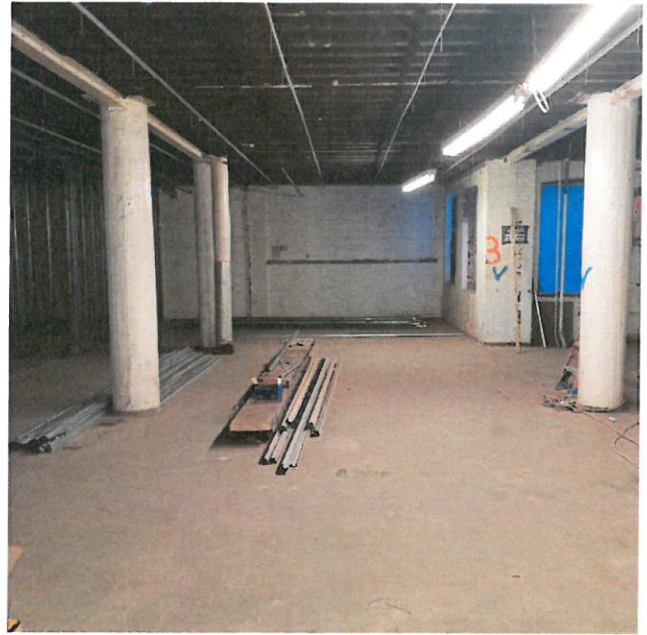
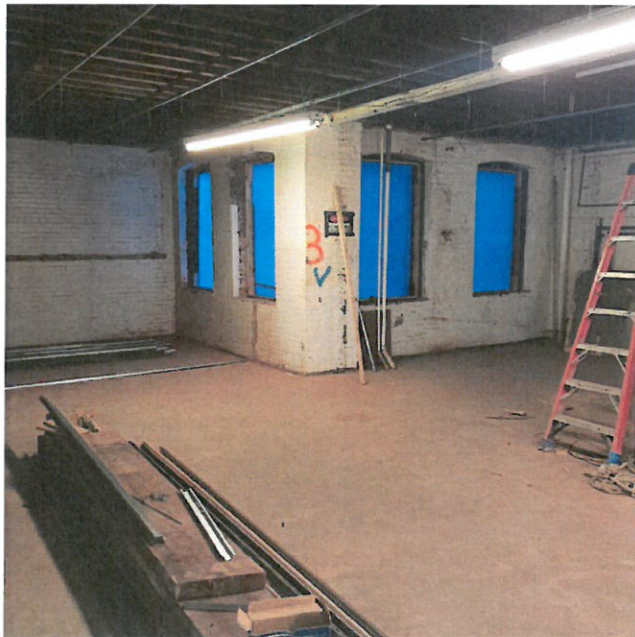
3rd Floor

Plumbing risers are set.

Steel framing and deck for stairs are in.

Stair partitions and duct shaft are framed

Rods for suspended ceiling are in.

Temp stairs installed.

No MEP other than water and waste risers.

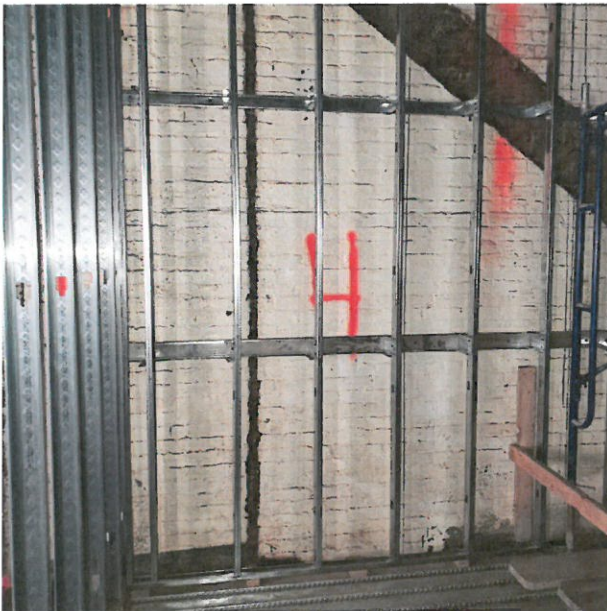
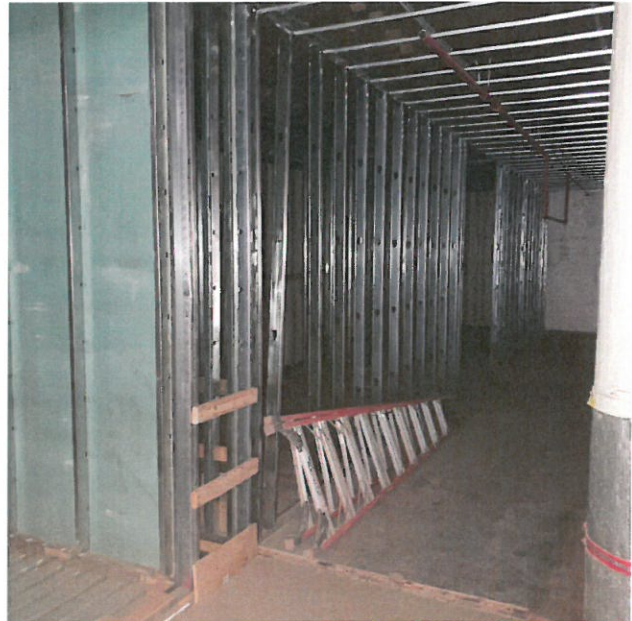
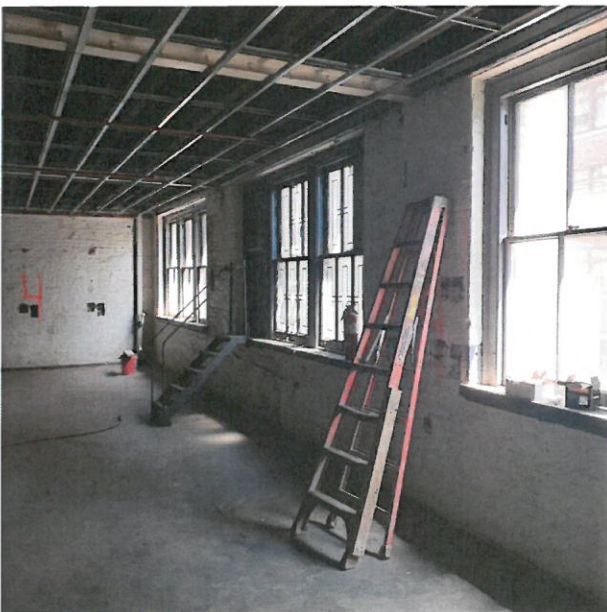
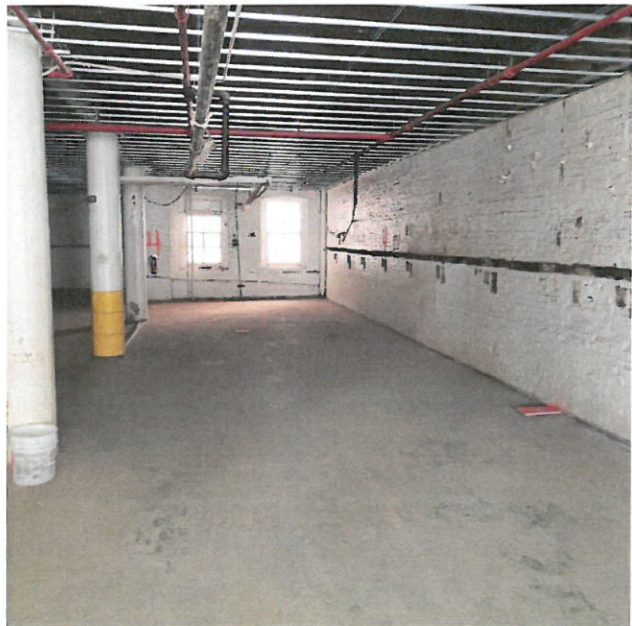
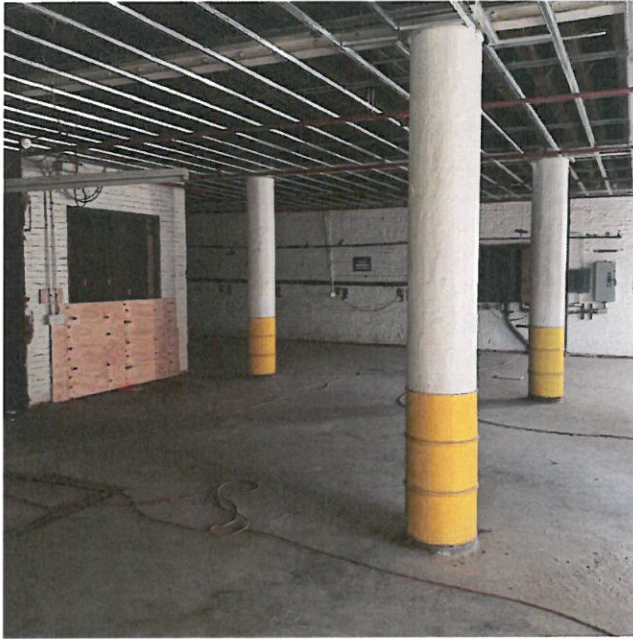
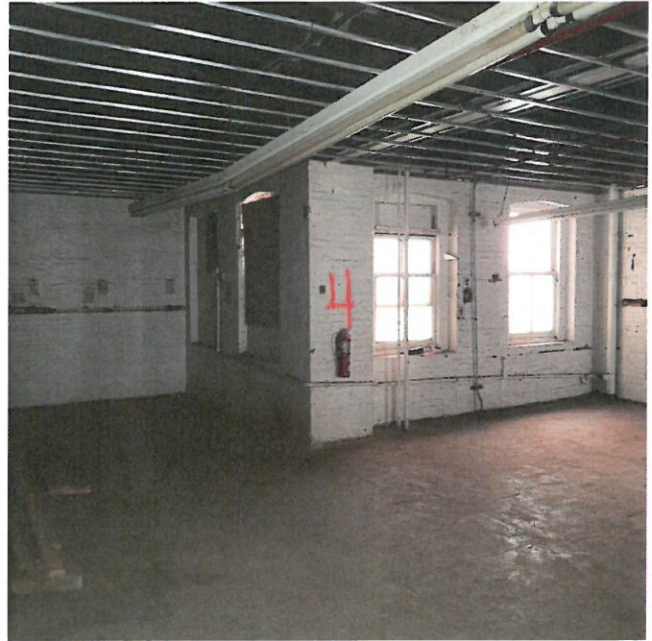
4th Floor

Plumbing risers are set.

Steel framing and deck for stairs are in.

Stair partitions and duct riser shaft are framed

Rods for suspended ceiling are in with black iron and furring.

Temp stairs installed.

No MEP other than water and waste.

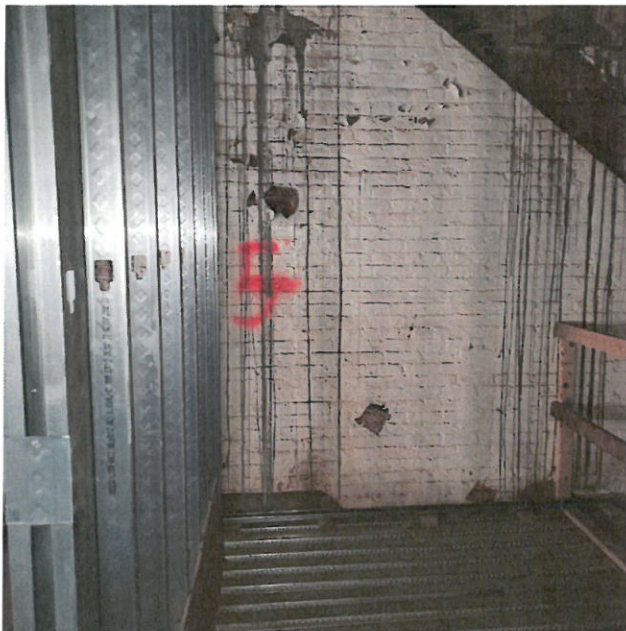
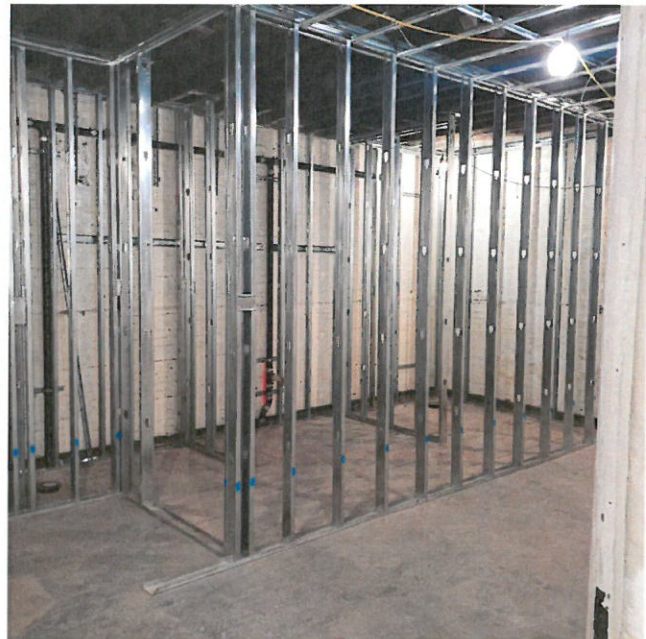
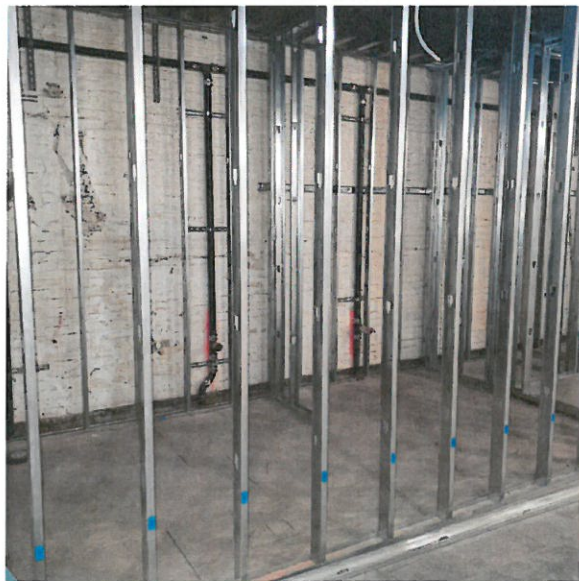
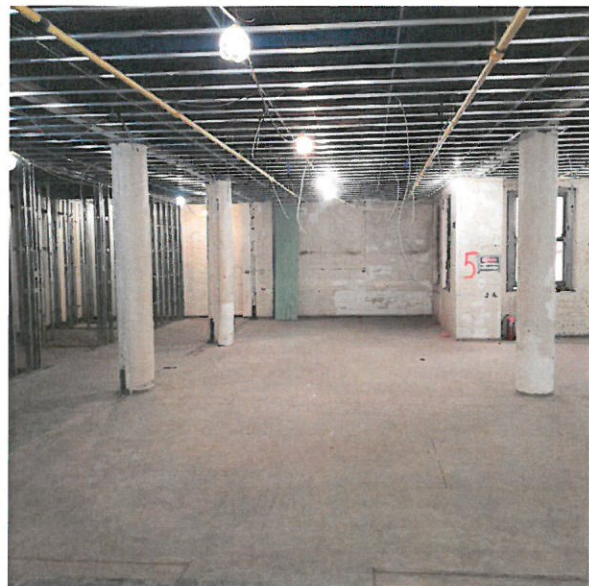
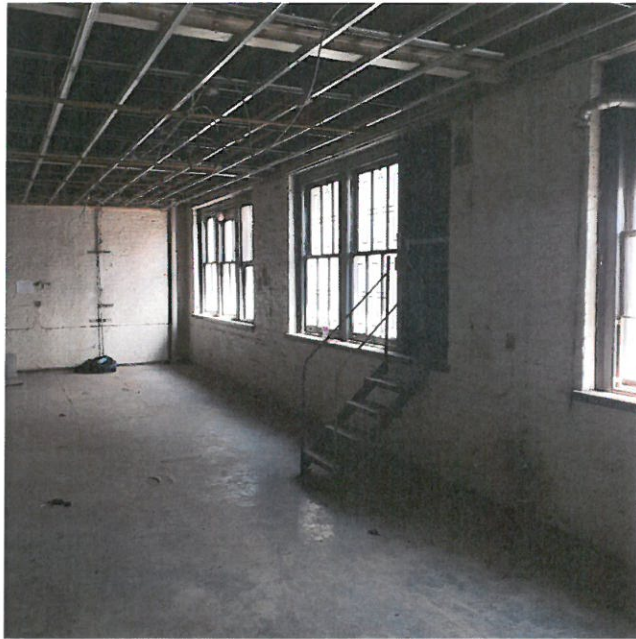
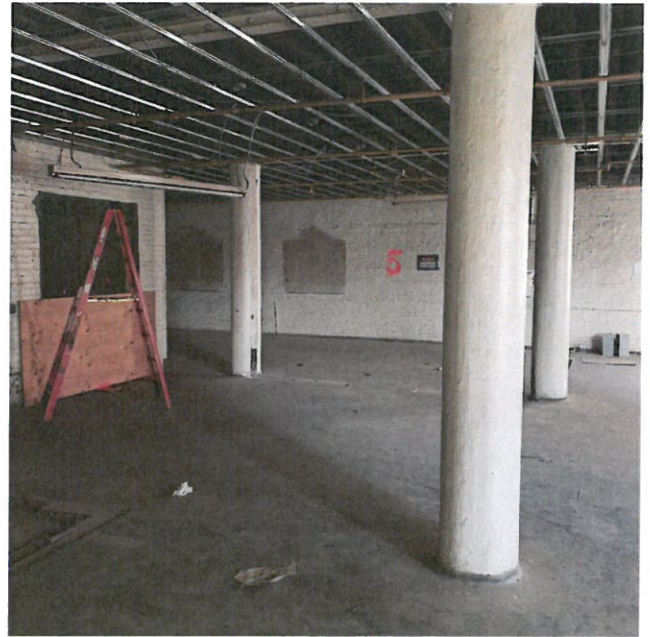
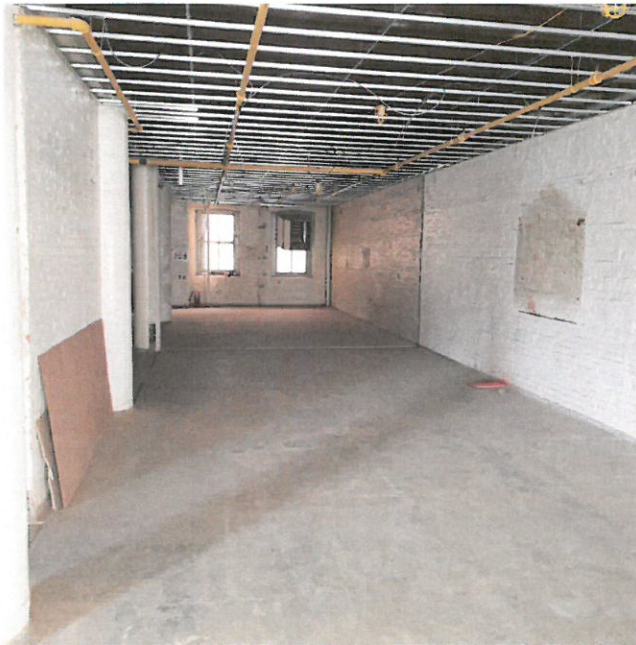
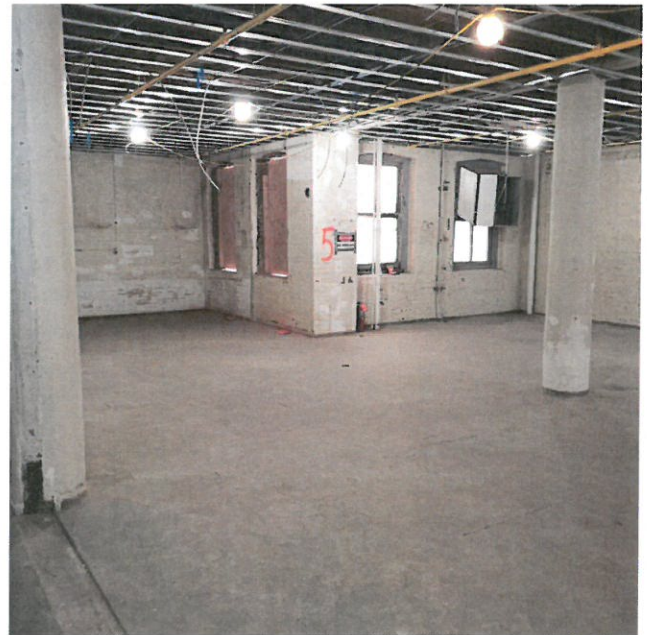
5th Floor

Plumbing risers are set.

Steel framing and deck for stairs are in.

Stair partitions, duct riser shaft and bathroom partitions are framed.

Suspended ceiling is in and framed with black iron and metal furring channel.

Temp stairs installed.

No MEP other than water and waste risers and bathroom roughing.

Fifth floor walls and ceilings framed and baths rough plumbed.

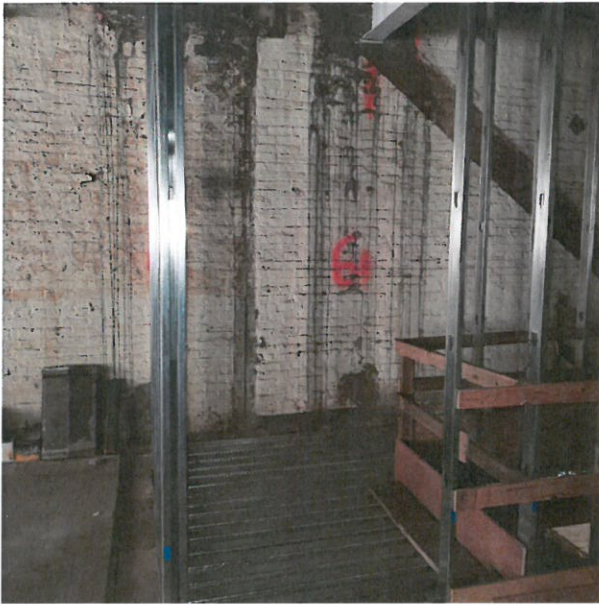
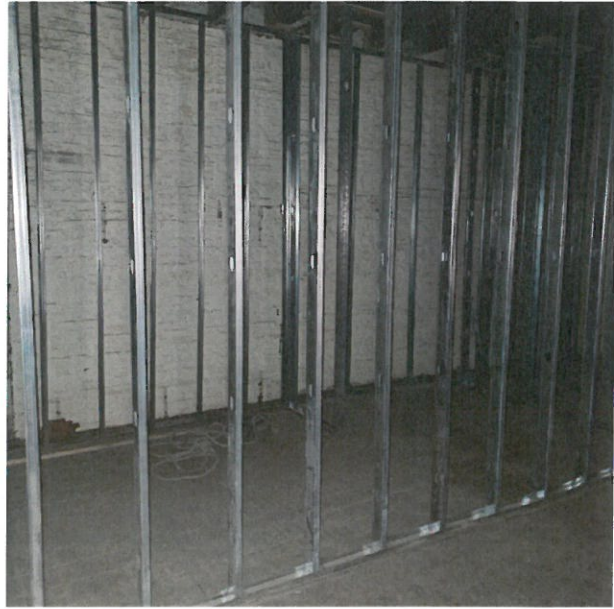
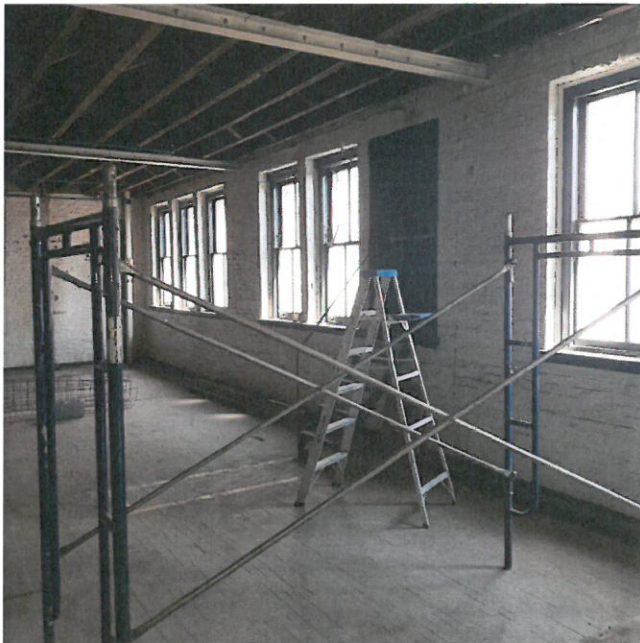
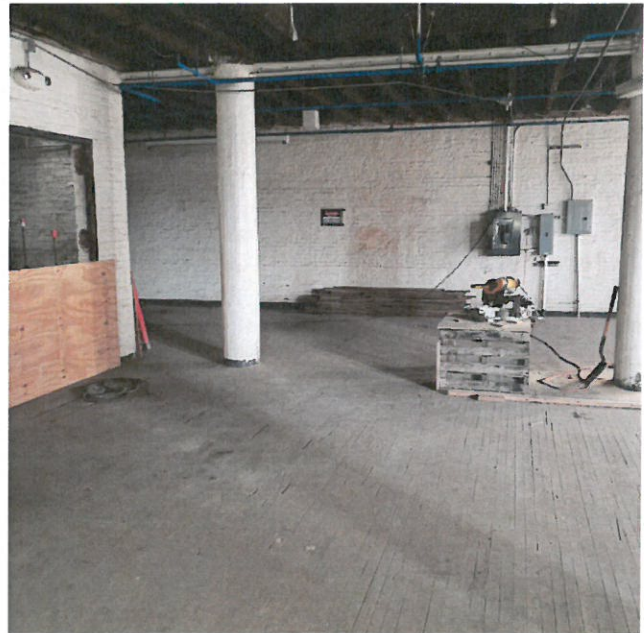
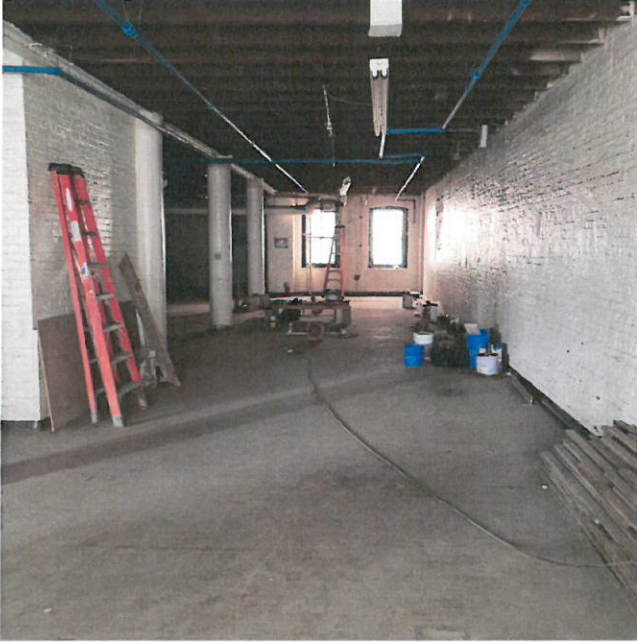
6th Floor

Plumbing risers are set.

Steel framing and deck for stairs are in.

Stair partitions are framed

Temp stairs installed.

No MEP other than water and waste risers.

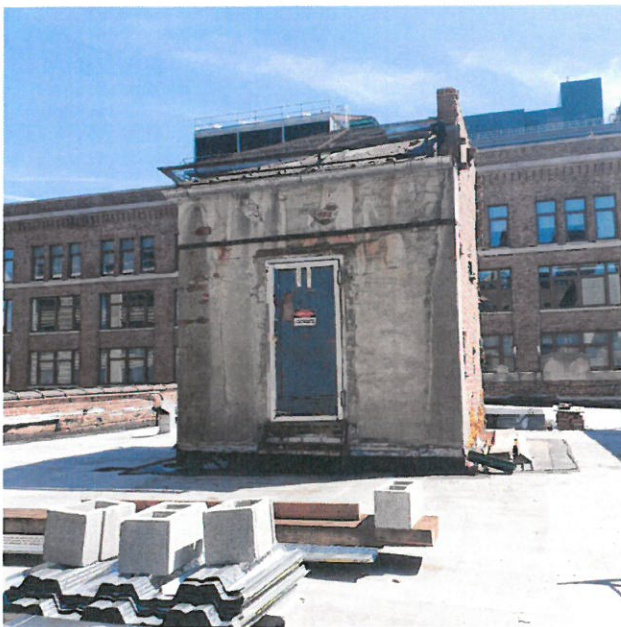
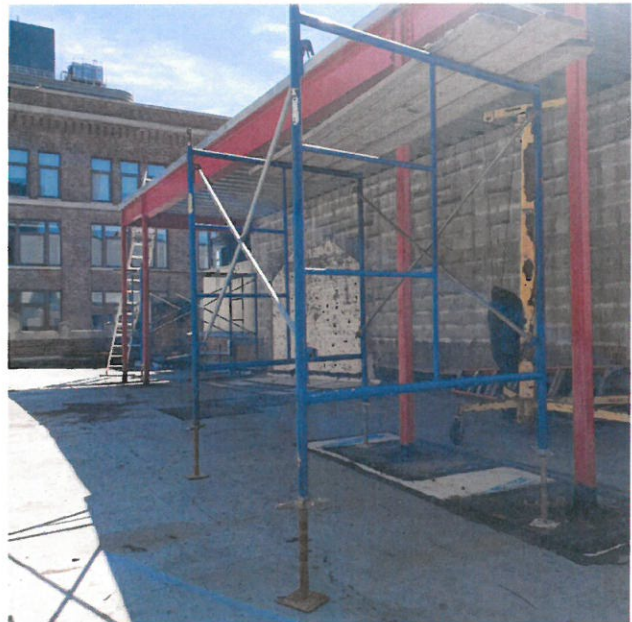
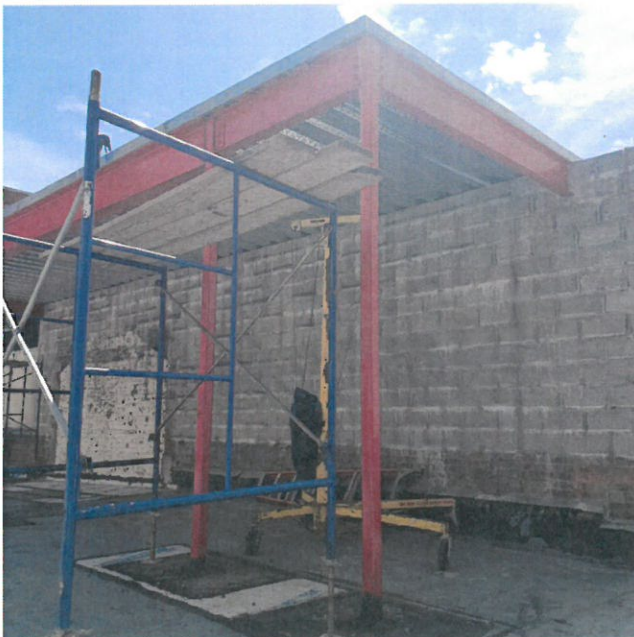
Facade needs work point and patch.

Windows are not replaced.

New punchout windows are not yet started.

Roof bulkhead steel framing and deck complete waiting for enclosure.

Elevator shaft is partially revised, no work at roof new landing, or machine room.
